1314 WEST 15TH STREET
FAMILY DEVELOPMENT

HUD NUMBER
RH-7

124 Unit Apartment Building Complex
Loomis Courts Apartments
1314 and 1342 West 15th Street
Chicago, IL 60608

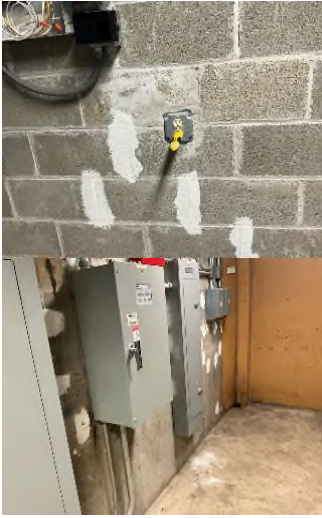
Outlet does not have visible damage and testing indicates it is not energized.	Not energize outlet electrical room

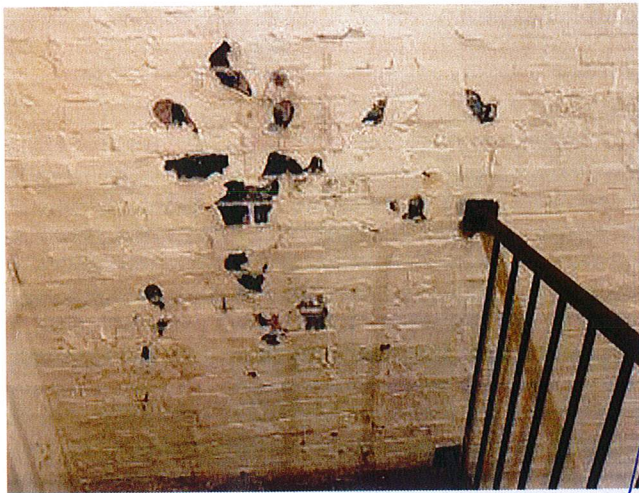
Interior Common Areas (Only Stairways).
Brick Walls and Concrete Support Columns and Beams with LBP. Deteriorated Walls only found in 1314 Building, NE Stairway, 6th Floor.

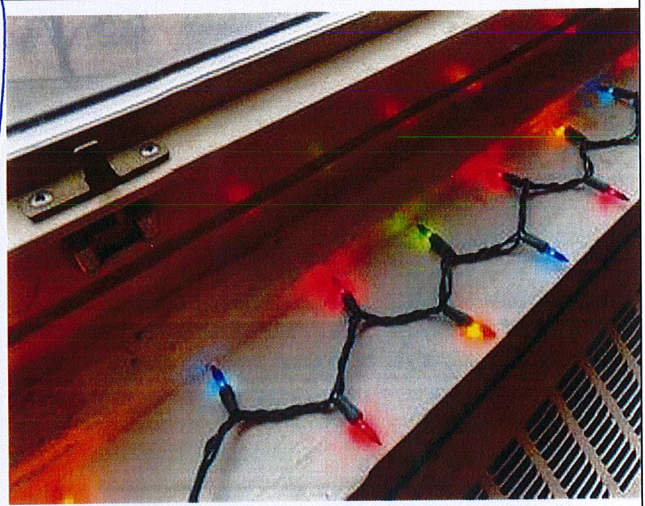
Interior Apartments. Metal Window Sills and Casings (Original to Building) with Intact LBP.

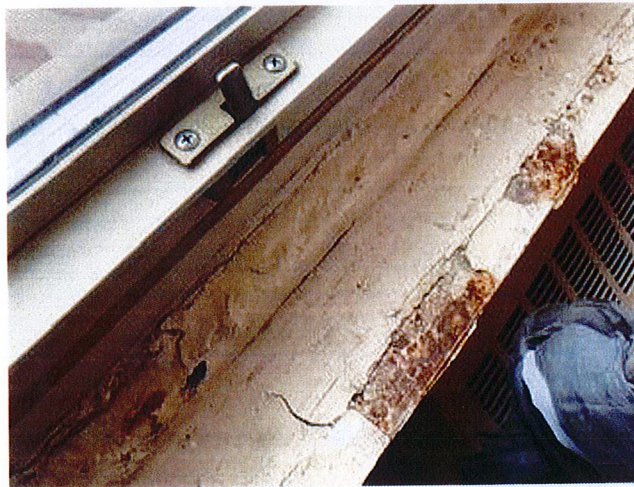
Interior Apartments. Metal Window Sills and Casings (Original to Building) with mostly Intact LBP (Some metal casings are deteriorated and need stabilized). Drywall and Plaster around windows tested negative for LBP.

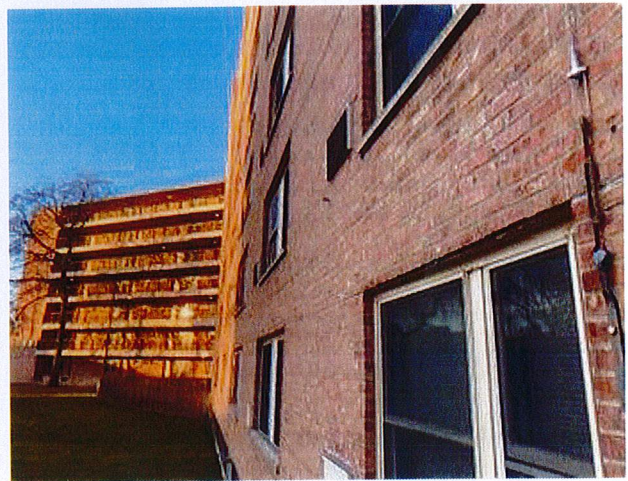
Exterior Building. Metal Hallway Fences and Lintels (over Doors and Windows) with Intact LBP.
